Manhole Inspection Summary

Manhole # S59E__004MH

Insp Date: **5/1/09 2:04 PM**

Location Address: **4400 E LOMBARD ST**

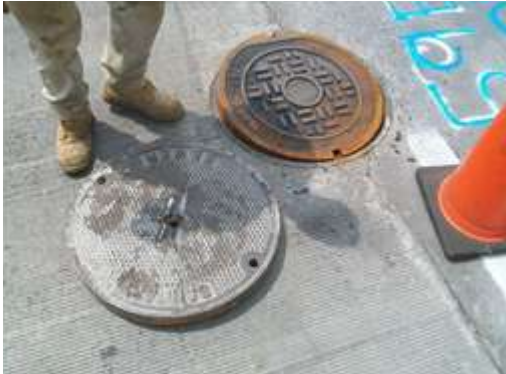
Miscellaneous

Comments **FORCED OPEN COVER AND COVER CRACKED IN OPENNING PROCESS, REPLACED COVER TO COMPLETE INSPECTION - TRAFFIC CONTROL WAS ALSO REQUIRED - NO FLOW IN MANHOLE, WATER IS STATIONARY IN THE CHANNEL**

REPLACED DAMAGED COVER

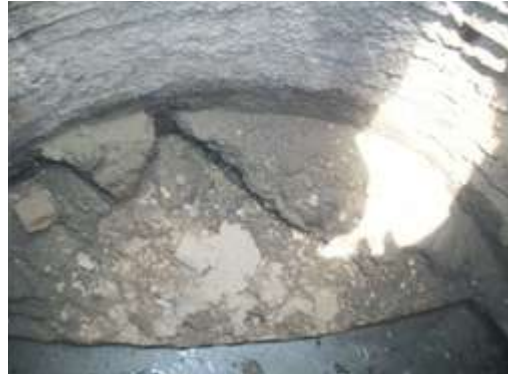
Defect 1

Infiltration: ☐ None ☐ Joint ☐ Cracks ☐ Mortar ☐ Roots ☒ **Wall**

Condition: ☐ Sound ☐ Cracked ☐ Root Intrusion ☐ Deteriorated ☐ Leaks ☒ **Debris**

bench debris; evidence of infiltration on barrel wall

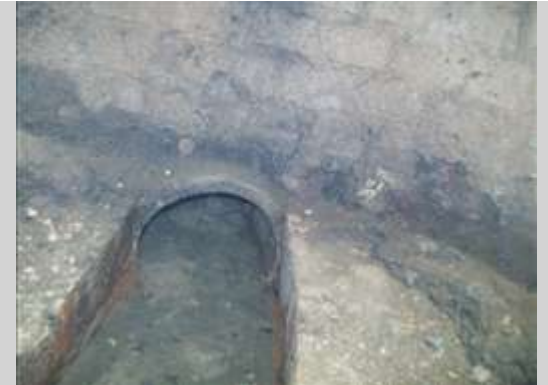
12 O'Clock Outflow

8 in. Circular Gravity Sewer
Pipe Out @ 12 O'Clock

Pipe Height: **8.4** (in.) Rod and Bar (Angled)
Pipe Material: **Clay** ☐ Pipe Lined
Invert Depth: **5.95** (ft.) Flow Characteristics: **None**
Deposits: ☒ None ☐ Mud ☐ Sludge ☐ Debris ☐ Grease
Silt Depth: **0** (in.) Deposits Extent:
Infiltration: **None** Pipe Seal Cond: **Sound**

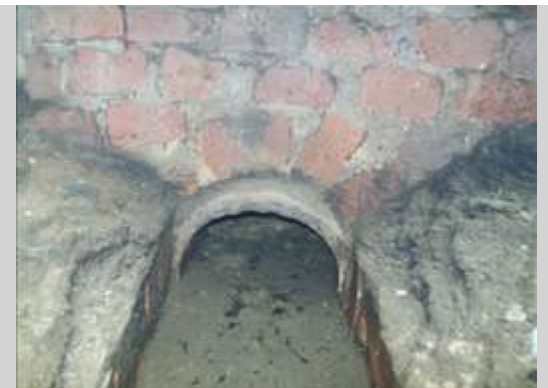
7 O'Clock Inflow

8 in. Circular Gravity Sewer
Pipe In @ 7 O'Clock

Pipe Height: **8.4** (in.) Rod and Bar (Angled)
Pipe Material: **Clay** ☐ Pipe Lined
Invert Depth: **5.78** (ft.) Flow Characteristics: **None**
Deposits: ☒ None ☐ Mud ☐ Sludge ☐ Debris ☐ Grease
Silt Depth: **0** (in.) Deposits Extent:
Infiltration: **None** Pipe Seal Cond: **Sound**
